Manhole Inspection Summary

Manhole # S35UU1017MH

Insp Date: **3/19/07 2:15 PM**

Location Address: **309 WOODBOURNE AVE**

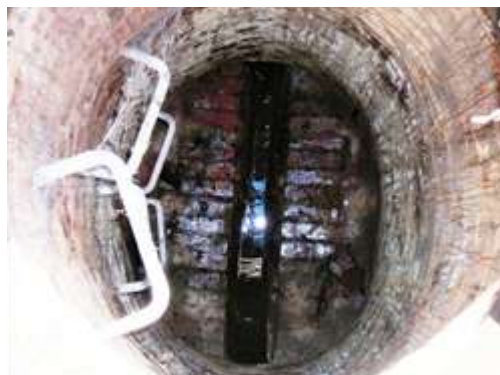
Top View

Bench debris.

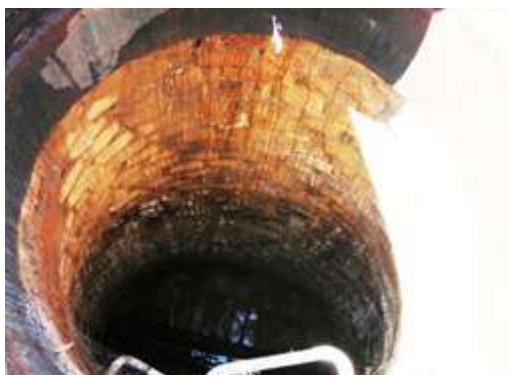
Defect

Frame leaks. Adjustment and Corbel deterioration and infiltration. Barrel infiltration - other side.

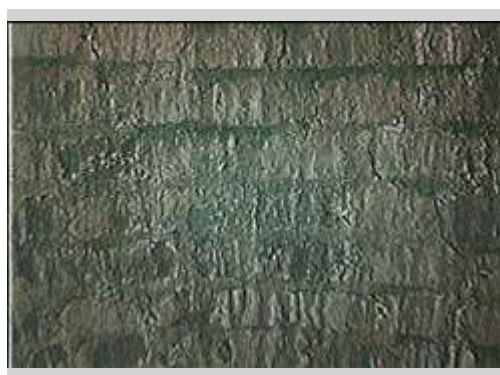
Defect

Barrel deterioration, cracks and infiltration.

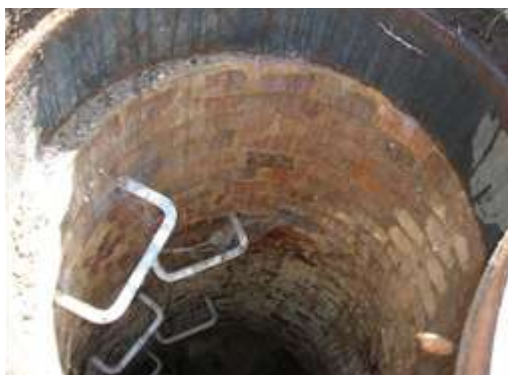
Defect

Frame leaks. Frame offset. Adjustment deterioration and infiltration. Barrel infiltration.

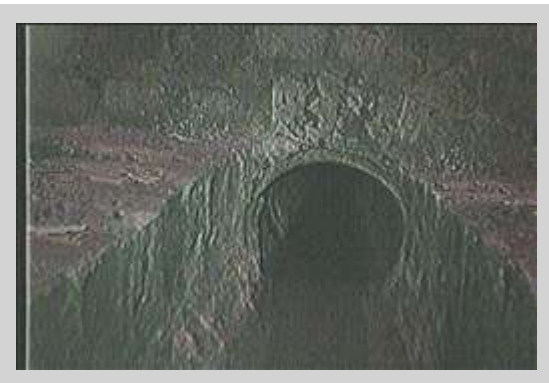
8 in. Circular Gravity Sewer Pipe In @ 6 O'Clock

Deposits: ☐ None ☐ Mud ☐ Sludge ☐ Debris ☒ Grease

Silt Depth: **0** (in.) Deposits Extent: **Light**

Infiltration: **Evidence** Pipe Seal Cond: **Cracked**
